CFRP Strengthening and monitoring of the Gröndals Bridge in Sweden

ABSTRACT: The Gröndal Bridge, is a large freivorbau bridge (pre-stressed concrete box bridge), approximately 400 meters in length with a free span of 120 m. It was opened to tram traffic in 2000. Just after opening cracks were noticed in the webs, these cracks have then increased, the size of the largest cracks exceeded 0.5 mm, and at the end of 2001 the bridge was temporarily strengthened. This was carried out with externally placed prestressed steel stays. The reason for cracking is still debated and will be further discussed in this paper. Nevertheless, it was clear that the bridge needed to be strengthened. The strengthening methods used were CFRP laminates in the Service Limit State (SLS) and prestressed dywidag stays in the Ultimate Limit State (ULS). The strengthening was carried out during 2002. At the same time monitoring of the bridge commenced, using LVDT crack gauges as well as optical fibre sensors.

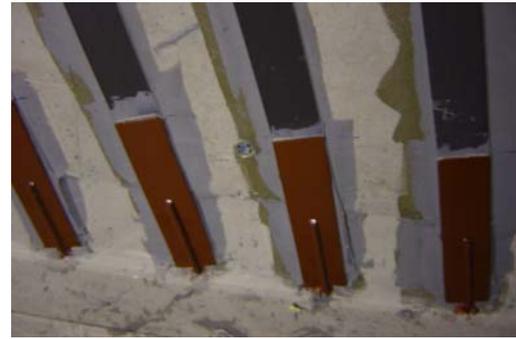
Figure 2 Anchor system for the CFRP laminates. The anchorages are bonded with an epoxy adhesive in pre-drilled holes in the flanges

In Figure 2 the anchorage system is shown. Here, steel plates with welded steel bars that were anchored by epoxy bonding in pre-drilled holes in the top and bottom flanges. The anchor length was approximately 250 mm.

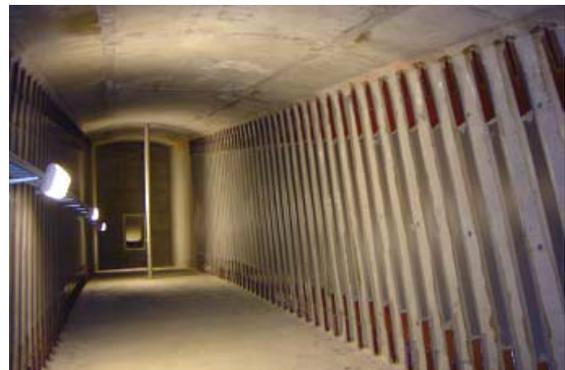
Figure 3 Result after strengthening - seen from inside the bridge. This photo shows strengthening approximately from section A to the column no 8.

The final result after strengthening is shown in Figure 3.

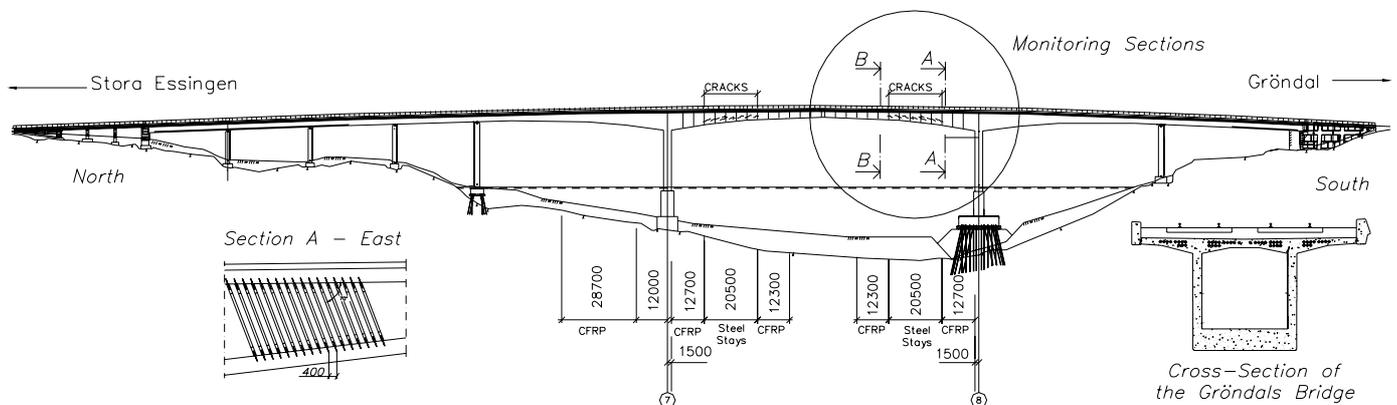
Figure 1 The Gröndals Bridge , CFRP strengthening and monitoring area

The main span of the Gröndals Bridge is 120 meters with two adjacent spans each of 70 meters (see Figure 1). The bridge carries two railway tracks which are placed symmetrically about the cross-section of the bridge. The bridge has no footpath.

The surfaces were thoroughly cleaned with pressurised air and vacuum cleaners. The surfaces to be bonded were treated with a primer for the system to enhance the bond. The laminates were bonded to the surface, the webs of the structure with a high quality epoxy adhesive, BPE[®] Lim 567, specific for the strengthening system used. The Young's modulus of the adhesive is approximately 6.5 GPa at 20 °C. The average thickness of the adhesive was 2 mm. A total of 2 500 meters of CFRP laminates was used for the bridge. The placement of the CFRP laminates in the Gröndal Bridge in section A, the east side is shown in Figure 1.

It can also be noticed in Figure 1 that the CFRP laminates have been bonded at an angle of 70° to the horizontal plane. This was in order that for the laminates to be bonded perpendicular to the direction of the cracks.

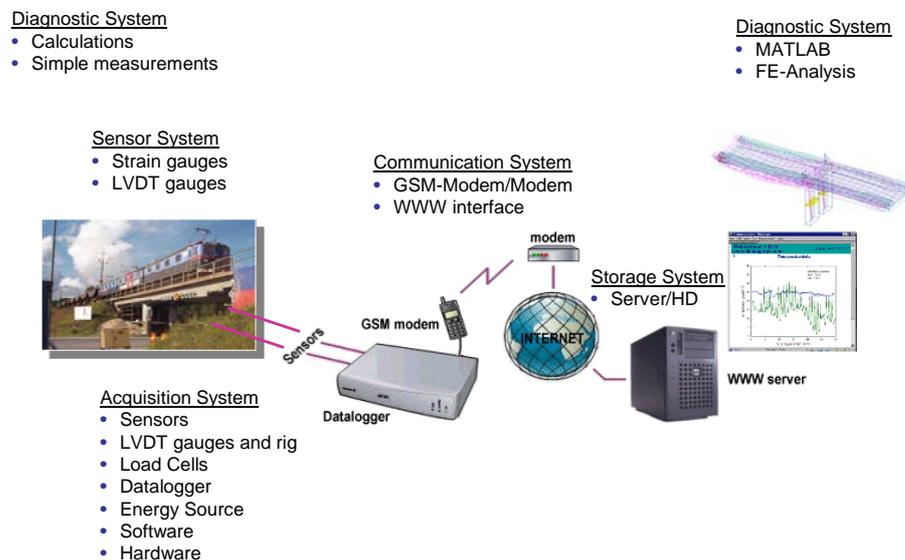
Figure 4 Structural Health Diagnostic System

To obtain the most out of a measurement program it is important to carry out SHD (Structural Health Diagnostics) in a structured way and that a well-planned procedure is followed. Luleå University of Technology has worked out a method termed Structural Health Diagnostics (SHD), which in short implies that a rough diagnosis is made on the structure; this can be simple calculations, on site visual inspections or minor measurements. Next it is decided what is to be measured and the purpose with the measurement. In this phase the acquisition system is also decided. Sensors and communications systems are established as well as hard- and software. On top of this, an evaluation system is connected which connects the data from the measurement to a model of the structure. From this action plans are then suggested. In figure 4 an example on a SHD for a railway bridge is shown.

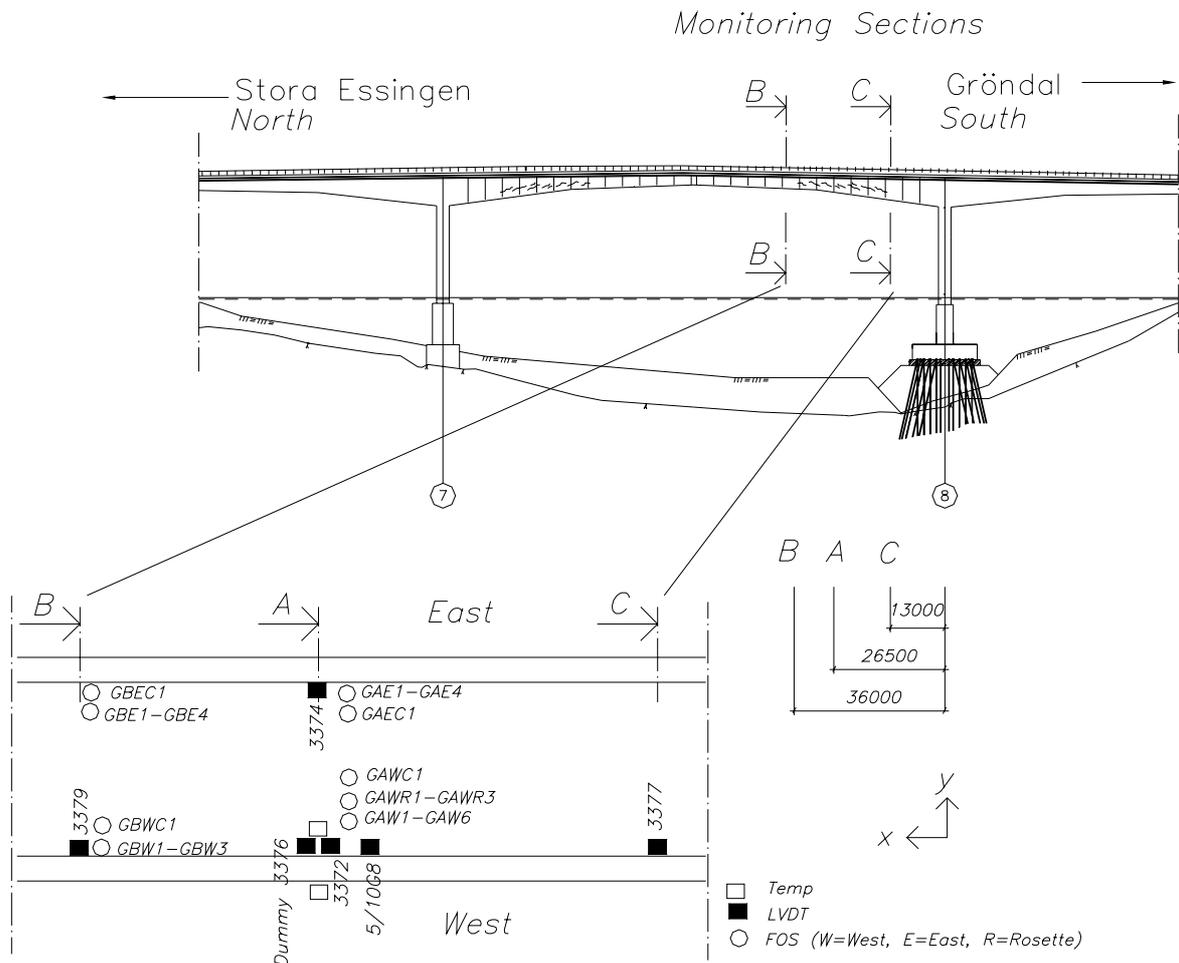
Figure 5 Position of gauges on the Gröndals Bridge

In total 32 FOS gauges have been installed on the Gröndals Bridge, they are all installed in section A and section B, see Figure 1 and Figure 5. In section A, 12 sensors have been installed on the west side where three were used to compensate for the temperature. Two of these sensors (including temperature compensation) are positioned on a section of CFRP laminates, the others on different locations of concrete cracks. On the east wall in the same section seven sensors are installed, five on the concrete (including temperature compensation) and two on a CFRP laminate also here including temperature compensation. In section B, west side, four sensors have been positioned on the concrete, one of which is for temperature compensation and two have been positioned on a CFRP laminate, where one is for temperature compensation. On the east side in the same section six sensors have been positioned on the concrete, one for temperature compensation and two on a CFRP laminate, of which one is for temperature compensation. The placement of all the gauges is shown in Figure 5.

As can be noticed in Figure 5 many gauges have been placed on the bridge. The filled rectangular blocks represent the LVDT's and the open rectangular blocks represent the thermocouples for the traditional system. The FOS are represented by open circles. In table 2 the sensors are presented systematically. For the FOS system the previously mentioned sensors for temperature compensation shall also be included, however, this is not recorded in Table 2.

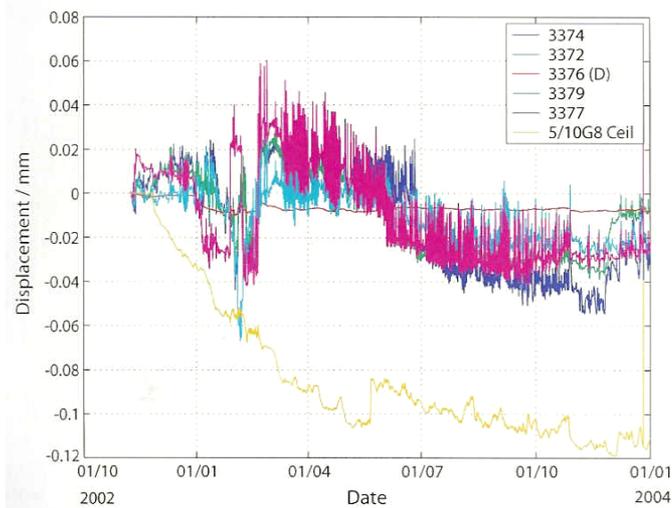
Figure 6 Result from crack-displacement with traditional monitoring system, from (James, 2004)

The result from the entire year 2003 for the Gröndals Bridge is shown in Figure 6, (James, 2004). It is not easy to extract a single value of the crack behaviour. However, from the figure it is possible to see that the cracks in the webs (indicated by sensors 3374, 3372, 3379 and 3377) do not appear to be of a progressive nature but rather that the cracks open and close depending on daily and seasonal temperature changes.

The crack widths of these gauges are not significantly different at the start of 2004 than at the start of 2003, with the variation in the order of 0.02-0.03 mm. The LVDT sensor (5/10G8) mounted between the underside of the top flange and the inside of the west web measures the longitudinal displacement in the top flange in relation to the web. The displacement appears from these results to be progressive even if the growth rate has decreased over the later half of the year.

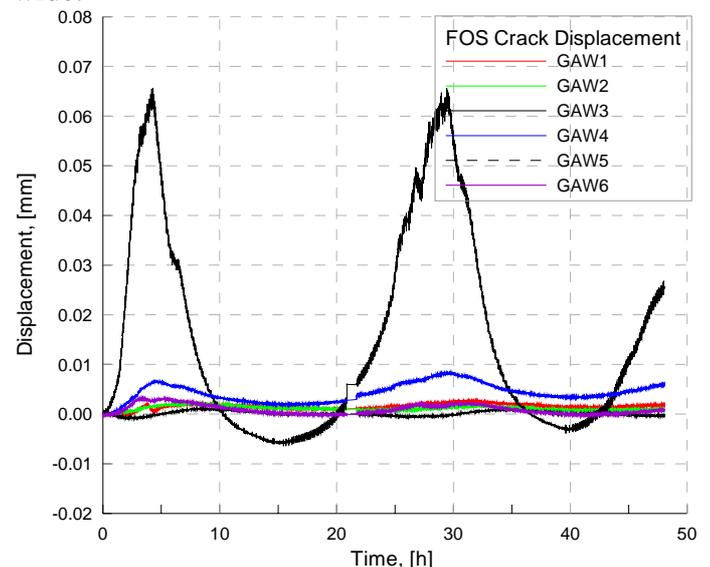
Figure 7 Result from crack-displacement with FOS system, (Täljsten & Hejll, 2004). Start date for monitoring 21-05-04

This paper will not present results from all sensors however, in figure 7 crack displacement from sensors GAW1 to GAW6 is shown. From Figure 7 it can be seen that crack displacement for GAW3 is considerably larger than for the others, here the FOS sensor is placed in the same crack as the LVDT gauge 3372, however during this time the crack displacement for the LVDT is approximately 0,035 mm (this can not be seen in Figure 6 due to the scale). The large variation over time is due to daily variation in temperature. In Figure 7 small jumps may also be noticed, approximately 0,001 mm wide.

This is due to the tram traffic, it seems that the effect of the temperature on opening and closing of the cracks is tenfold to the traffic load.

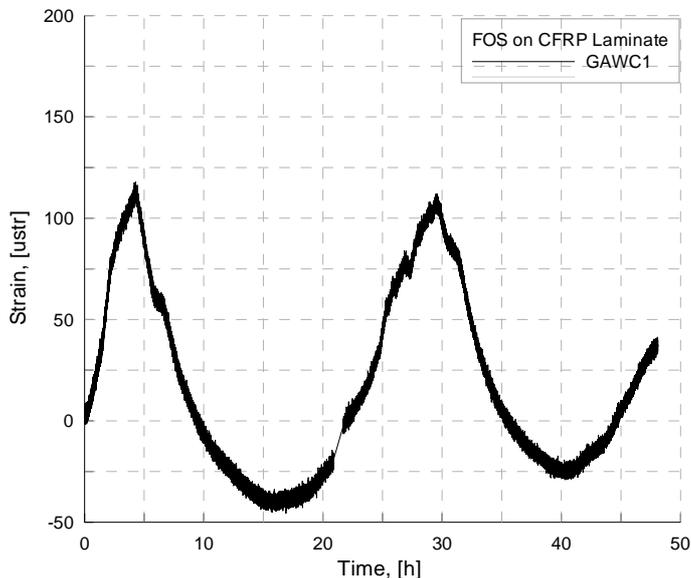
Figure 8 Result from crack-displacement with FOS system, (Täljsten & Hejll, 2004)

Over the same crack as in Figure 7 a CFRP laminate has been bonded, in Figure 8 the strain is recorded in this laminate in the same position as the crack. A calculation of stress gives a level of approximately 30 MPa in the laminate.
