FRP INTERNATIONAL

The Official Newsletter of the International Institute for FRP in Construction

Volume 3, Issue 2

Real-Time and Hand-Held Microwave NDE Technology for Inspection of FRP-Wrapped Concrete Structures

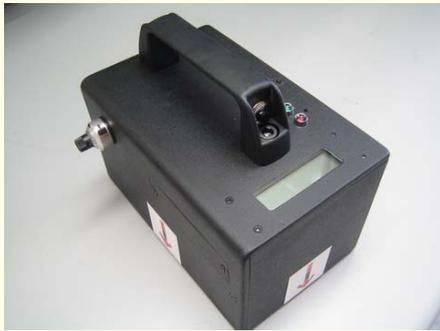
Figure 4. GAP-CAT-1100 Hand-Held All-In-One-Device

Defects and damage in a structural subsurface are detected and displayed in a visualized manner, in real time, by analyzing the reflected waves in comparison with a reference measured on the same structure at a location without defects/damage. GAP-CAT-1100, a hand-held all-in-one device, can indicate defects/damage by red and green lights, as shown in Figure 4.

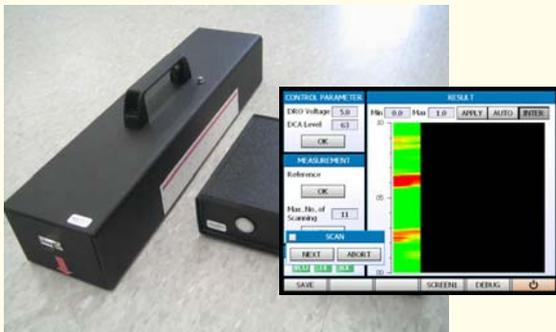
Figure 5. GAP-CAT-1200 With Real-Time Imaging Capability

GAP-CAT-1200, a hand-held scanner, can provide real-time scanned image on a computer screen, as shown in Figure 5. The image can be recorded for long-term monitoring and comparison.

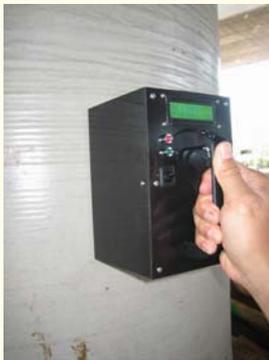
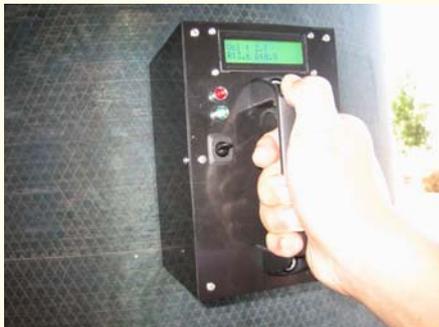
So far five major evaluation tests of the microwave NDE technology have been performed in the field. The first two evaluations were carried out at the Caltrans' FRP demonstration site located at I-10, Los Angeles, CA, on May 2 and August 29, 2005, in collaboration with the California Department of Transportation (Caltrans). The site involves concrete bridge columns wrapped with various types of E-glass and carbon FRP jackets for seismic retrofit purposes. Two columns, one wrapped with a 3-layer E-glass prefabricated jacket and the other with a single-layer carbon FRP (hand lay-up) jacket were selected for evaluation (Figure 8). In Column 1, an area of 0.5 m² was manually scanned in less than 4 minutes. A debonding area of 5 cm in diameter was detected by the device and later confirmed with manual coin tapping. In Column 2 (with carbon FRP), a debonding area of 3 cm in diameter was detected and later confirmed with coin tapping. Smaller debonds detected by the NDE device could not be verified by manual tapping. Tapping could not quantify the dimensions of the debonds either.

Figure 8(a). Glass FRP Jacketed Columns

Figure 8(b). Carbon FRP jacketed Columns

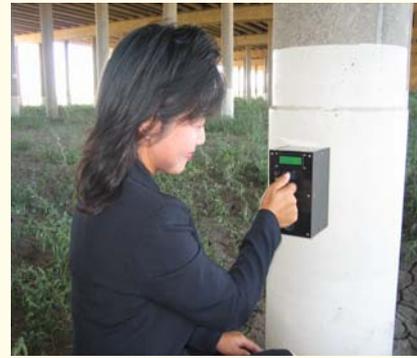
Figure 9. Field Test at I-80 Yolo Causeway Viaduct in California

A similar evaluation was performed on August 31, 2005 on the I-80 Yolo Causeway Viaduct in Sacramento, CA, where more than two thousand concrete columns were retrofitted with prefabricated FRP jackets. The fourth evaluation test was performed on November 8, 2005 on an FRP-wrapped concrete bridge column in collaboration with the New York State Department of Transportation (NYSDOT). The column, as shown in Figure 10, is located at the south face of a bridge on Congress Street in Albany, NY.

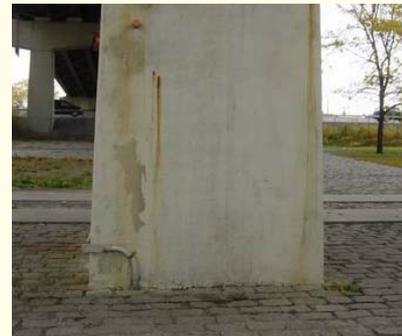
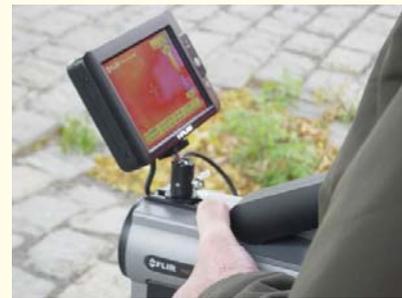
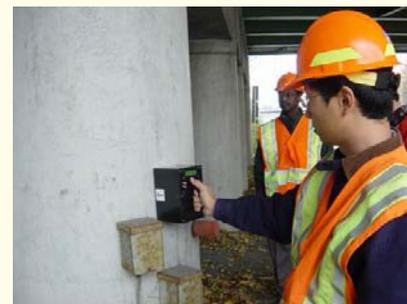
Figure 10(a). E-Glass FRP Wrapped Column

Figure 10(b). Thermography Using Infrared Camera

Figure 10(c). Hand-Held All-In-ONE Microwave NDE Device

It is a 1.2 m by 1.2 m rectangular concrete column wrapped with one layer of hand lay-up E-glass FRP using epoxy resin. NYDOT engineers periodically take thermographs the FRP-wrapped bridge column using a passive-type infrared camera (that does not require pre-heating). The thermograph taken at the column revealed one debonding area that is approximately 0.2 m². However, the scanned results over this area by the microwave NDE device indicated four small debonding areas, each with a diameter of 5 cm, instead of one large debonding area. These small debonds were confirmed by manual coin tapping. It was found that the passive thermograph is highly sensitive to environment conditions. It took approximately 3 minutes to scan this 0.2 m² area and to mark the four debonds.

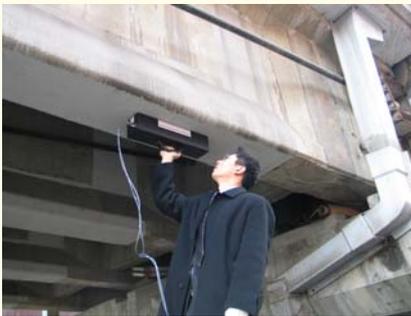
The fifth field evaluation took place on March 2, 2006 on an FRP-wrapped concrete girder of the Dang-Jeong Overcrossing located at Gun-Po, Korea. Eight years ago, the bridge girder was retrofitted by Conclinic Co. Ltd. with two layers of E-Glass FRP sheets and external post-tensioning as shown in Figure 11.

Figure 11(a). Inspection of FRP-Wrapped Girders

Figure 11(b). Scanned Microwave Images

First, GAP-CAT-1100 (the device with light indicator) was used to pre-scan a large FRP-wrapped girder surface. Although majority of the area showed no sign of debonds (green light), two debonding spots (red light) were identified. Then, more detailed inspection was performed by GAP-CAT-1200, which is capable of providing a real-time image of the scanned area. Figure 11(b) shows the two real-time images revealing the details of the debonding areas. This field evaluation proved the ease of use and the effectiveness of the microwave NDE technology.

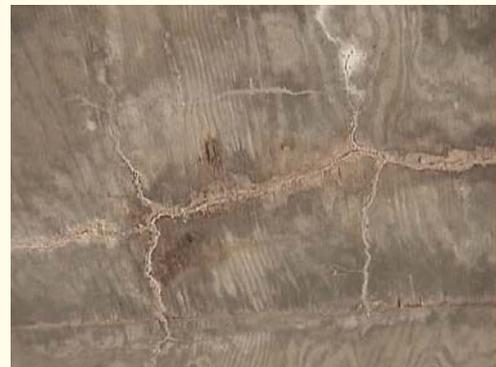
Figure 2. Transverse and Longitudinal Cracking on Bridge Deck

A visual inspection of the Watson Wash Bridge reveals a significant number of transverse cracks in the soffit of the bridge deck. The spacing of these cracks is approximately 14 cm corresponding to the average spacing of the transverse reinforcement in the deck of the bridge. Transverse and longitudinal cracking exist near the center of bay 4 of Frame S-3 which corresponds to the right wheel load of east bound traffic on the right lane of I-40 of the Watson Wash Bridge. The evenly spaced cracking in both directions on the bridge soffit indicates the potential for punching shear failures. Figure 2 shows the longitudinal and transverse crack patterns on the bridge deck. The sequence of damage observed on the structure is as follows. First, the development of transverse cracks effectively reduces the slab to a series of transverse beams normal to the direction of traffic. Subsequently, longitudinal cracks develop on the bridge deck soffit creating the potential for punching shear failure in the deck slab.

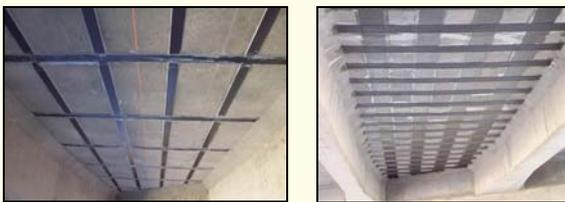
Figure 3. Completed Rehabilitation, Adhesive Bonding (Left) and Wet Lay-up (Right)

Completed rehabilitations are shown in Figure 3 for wet lay-up and pultruded CFRP composites.

The minimum requirement for the deck rehabilitation is prevention of punching shear failure. Locations span 8, bay 1 (S8B1), S9B1, and S9B4 are rehabilitated with pultruded CFRP composites for the punching shear load criterion. Locations S8B2, S8B3, S9B2, and S9B3 are rehabilitated considering the Permit truckload requirement, 106.8 KN (24 kips), with wet lay-up CFRP in S8B3, S9B3 and pultruded CFRP in S8B2, S9B2. Location S8B4 is left unrehabilitated for purposes of comparison.
